ACTION MEMORANDUM (RV2)

SUBJECT: Request for Approval of Project Ceiling Increase, 12-Month and \$2 Million Exemptions for CERCLA Removal Action at the TechCity Superfund Site, Town of Ulster, Ulster County, NY

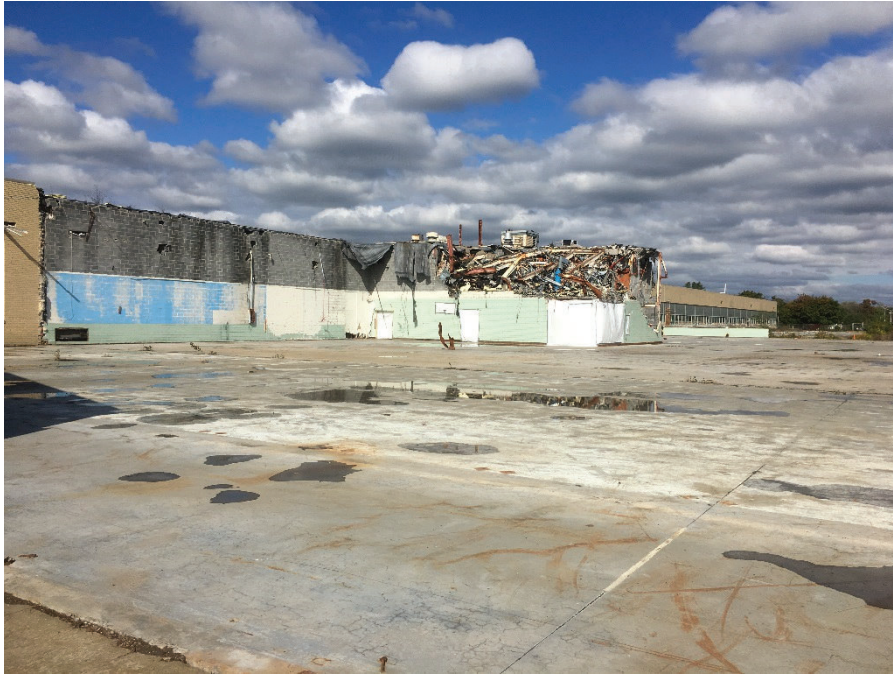
Photograph 1: View of the partially demolished Building 2 at the TechCity Site (the Site). The U.S. Environmental Protection Agency (EPA) and Weston Solutions, Inc., Removal Support Team 3 (RST 3) performed Removal Assessment sampling of suspected asbestos-containing material (SACM) in Building 2.

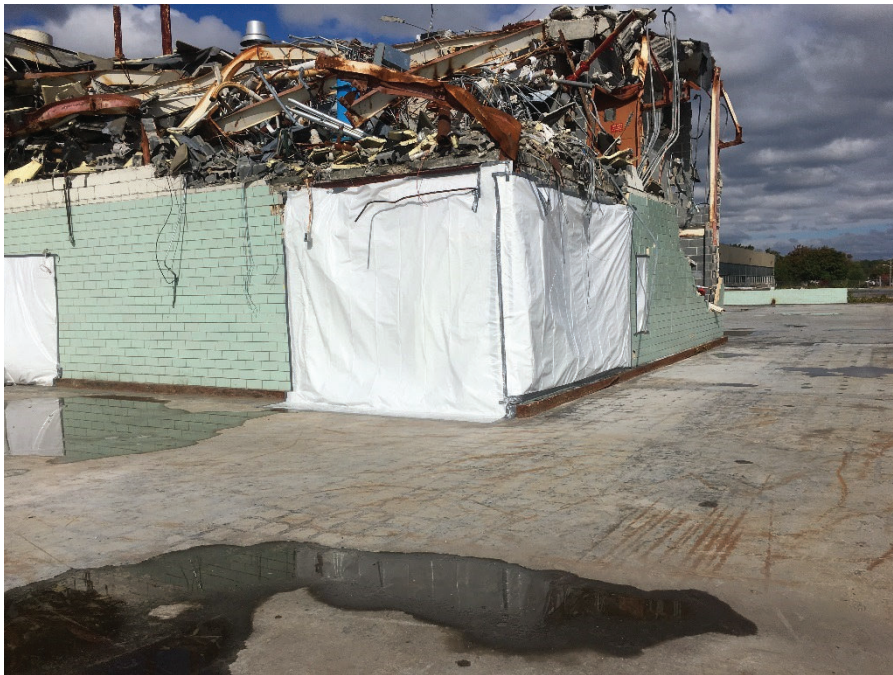
Photograph 2: A total of 10 bulk SACM samples were collected for laboratory analysis from building materials located throughout the demolished structure of Building 2 in order to determine if the building materials contained asbestos.

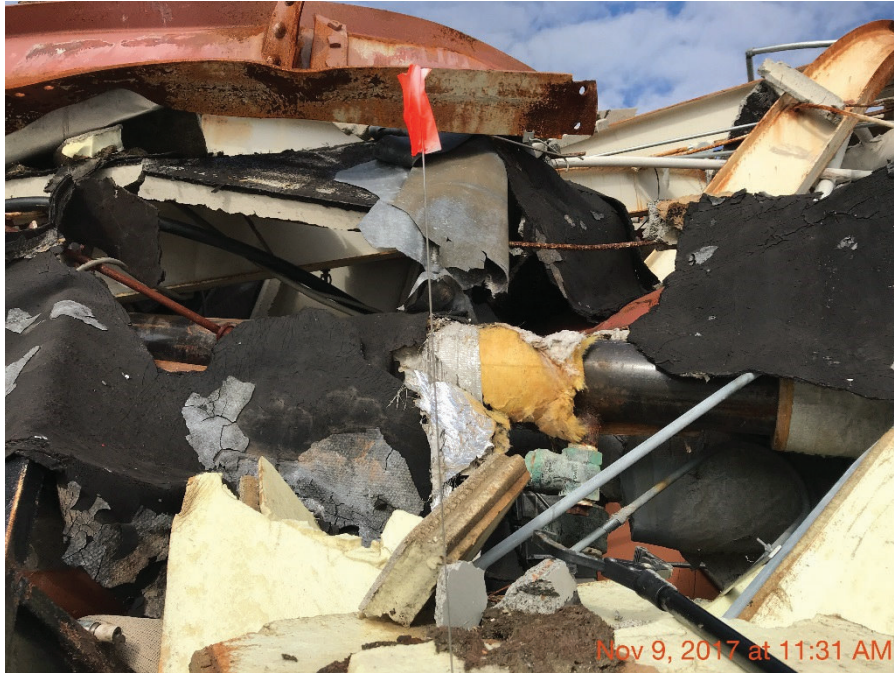
Photograph 3: View of sample location P001-BULK009 from which sample P001-BULK009-01 was collected.

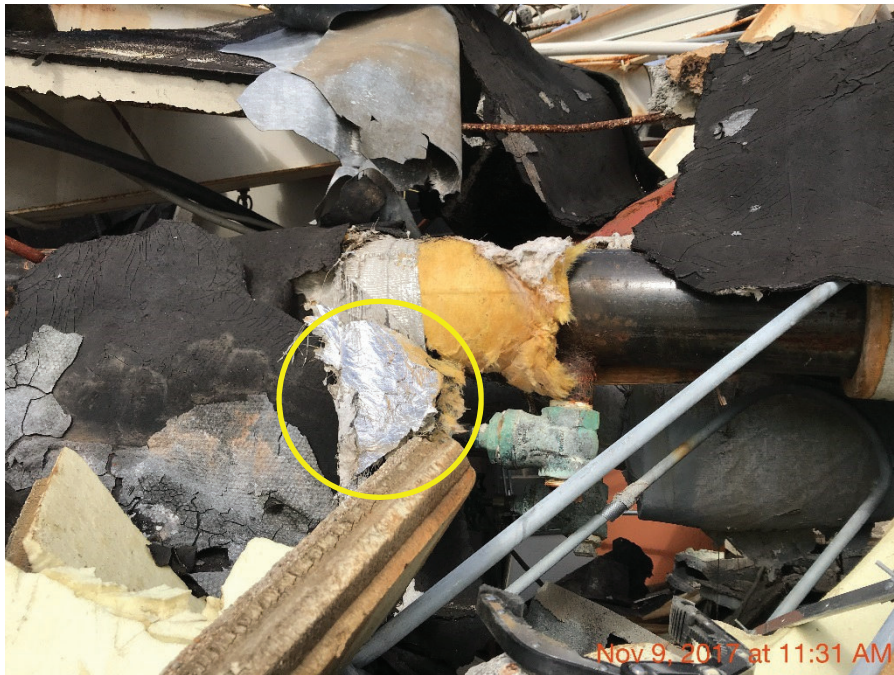
Photograph 4: Close up view of P001-BULK009-01. The bulk SACM sample is suspected to be pipe insulation.

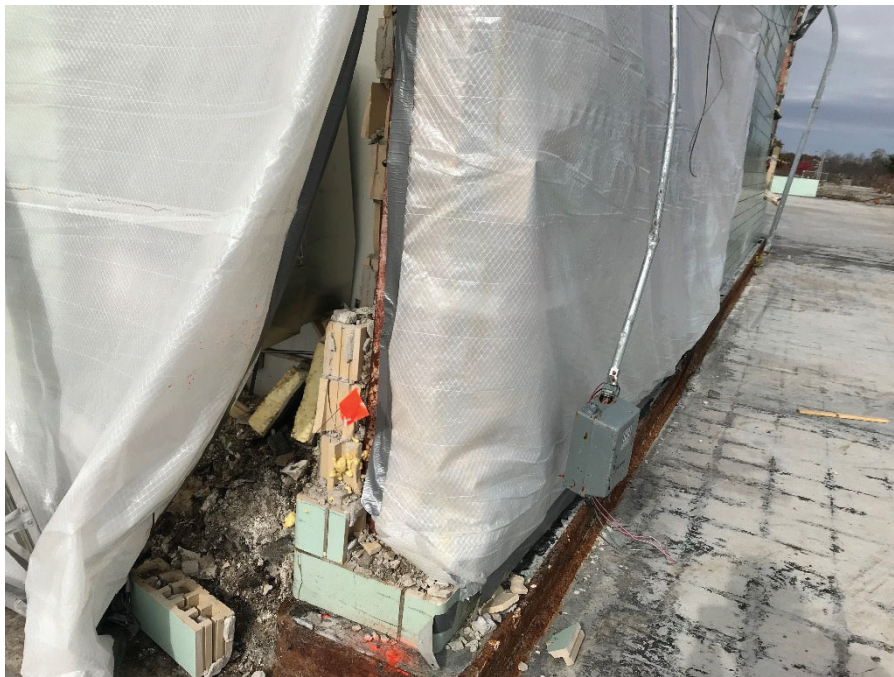
Photograph 5: View of sample location P001-BULK010 from which P001-BULK010-01 was collected.

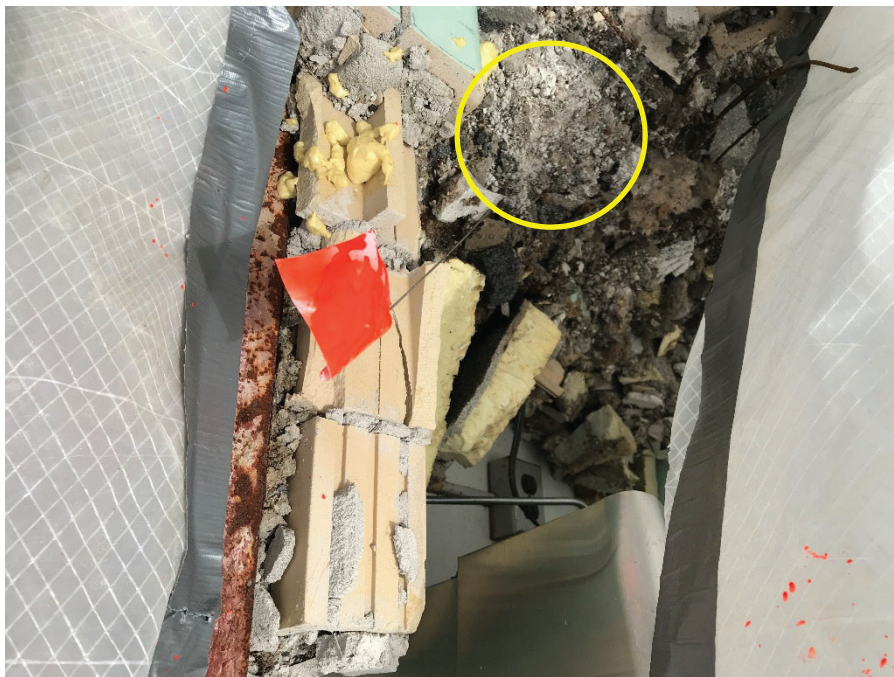
Photograph 6: Close up view of P001-BULK010-01. The bulk SACM sample is suspected to be deteriorated drywall.

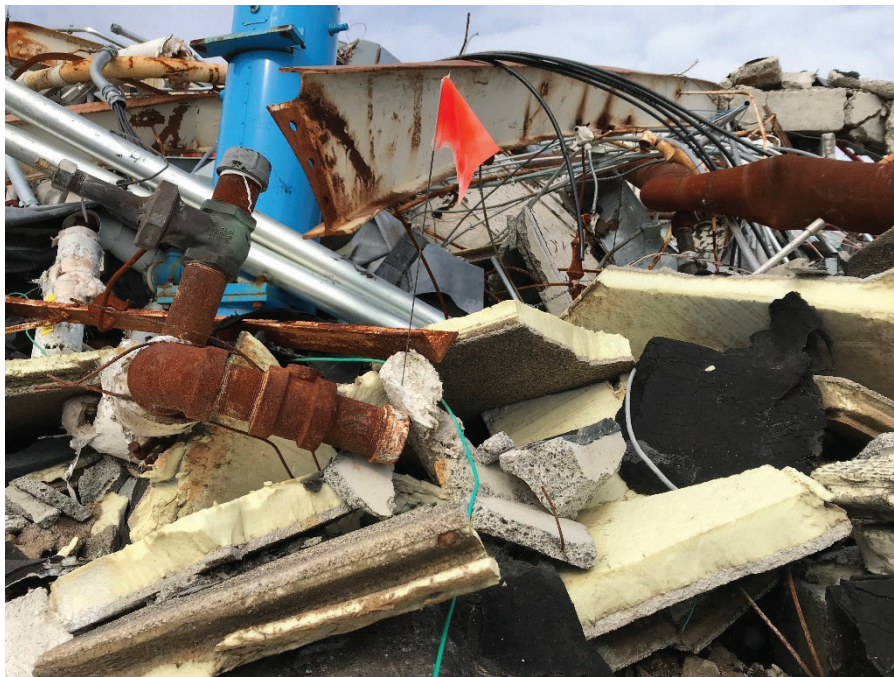
Photograph 7: View of sample location P001-BULK011 from which P001-BULK011-01 was collected.

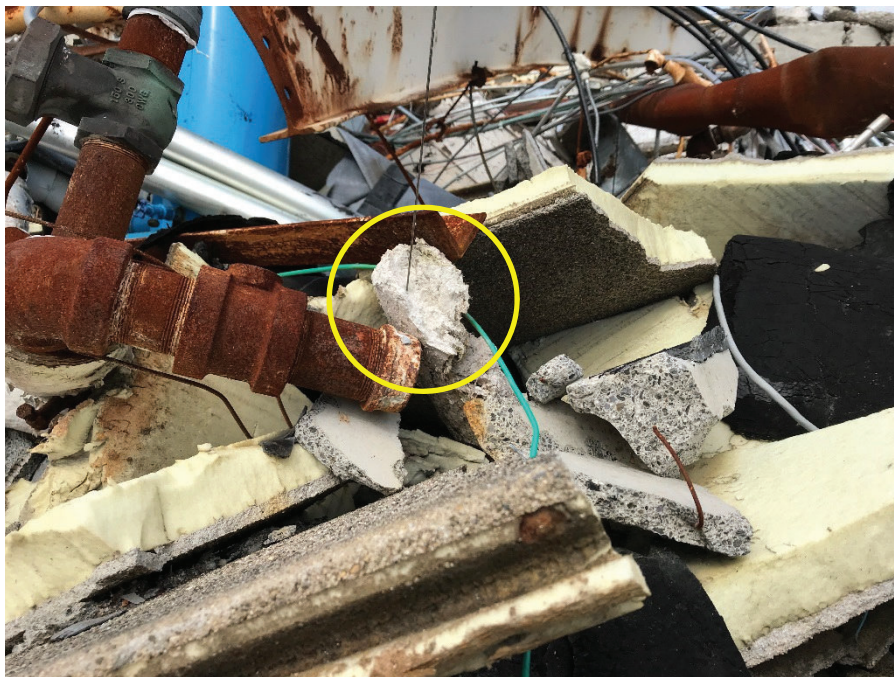
Photograph 8: Close up view of P001-BULK011-01. The bulk SACM sample is suspected to be pipe insulation.

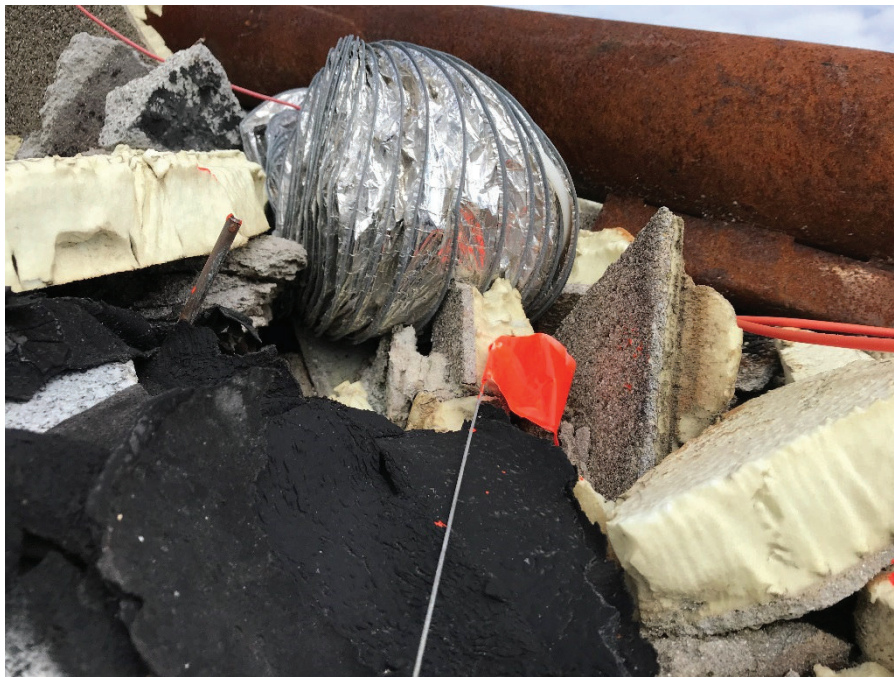
Photograph 9: View of sample location P001-BULK012 from which P001-BULK012-01 was collected.

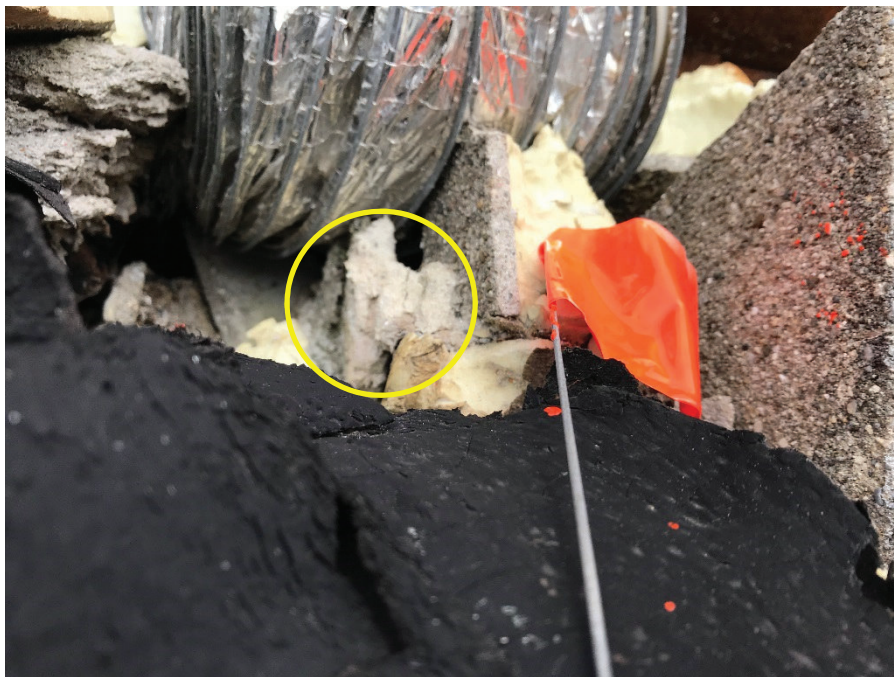
Photograph 10: Close up view of P001-BULK012-01. The bulk SACM sample is suspected to be pipe insulation.

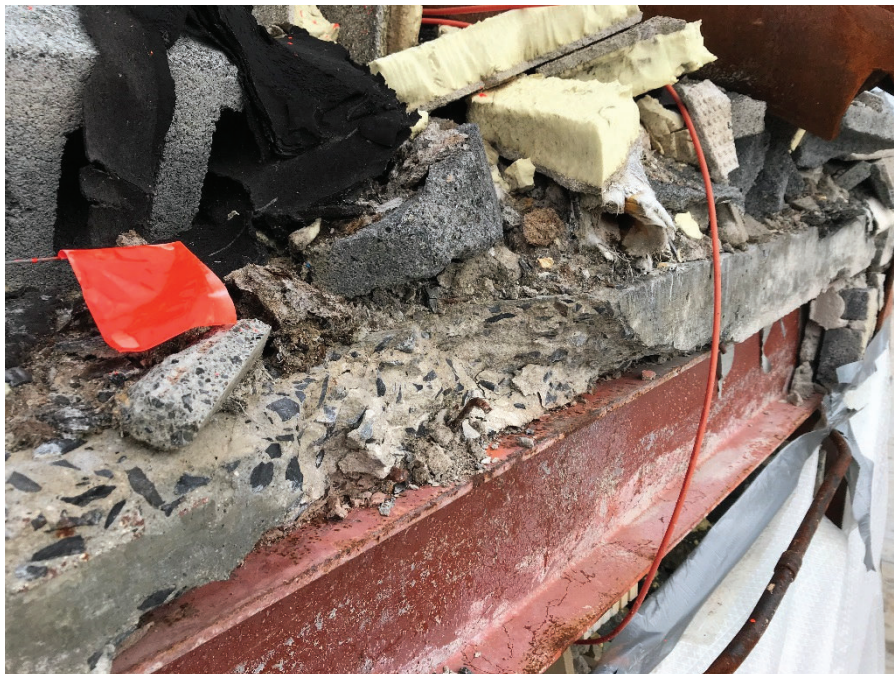
Photograph 11: View of sample location P001-BULK013 from which P001-BULK013-01 was collected.

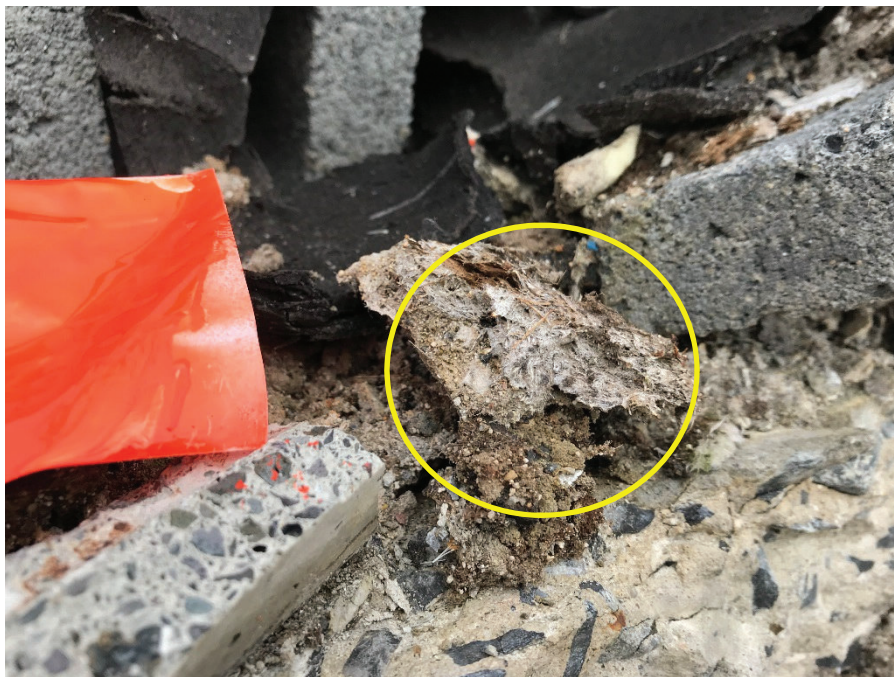
Photograph 12: Close up view of P001-BULK013-01. The bulk SACM sample is suspected to be a type of insulation coated with tar.

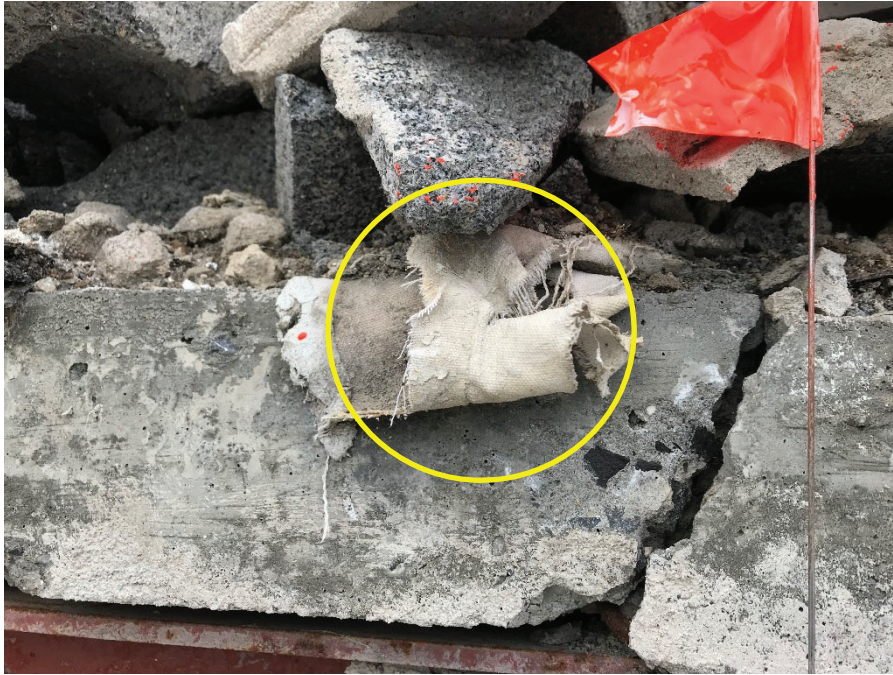
Photograph 13: View of sample location P001-BULK014 from which P001-BULK014-01 was collected. The bulk SACM sample is suspected to be insulation and pipe wrap.

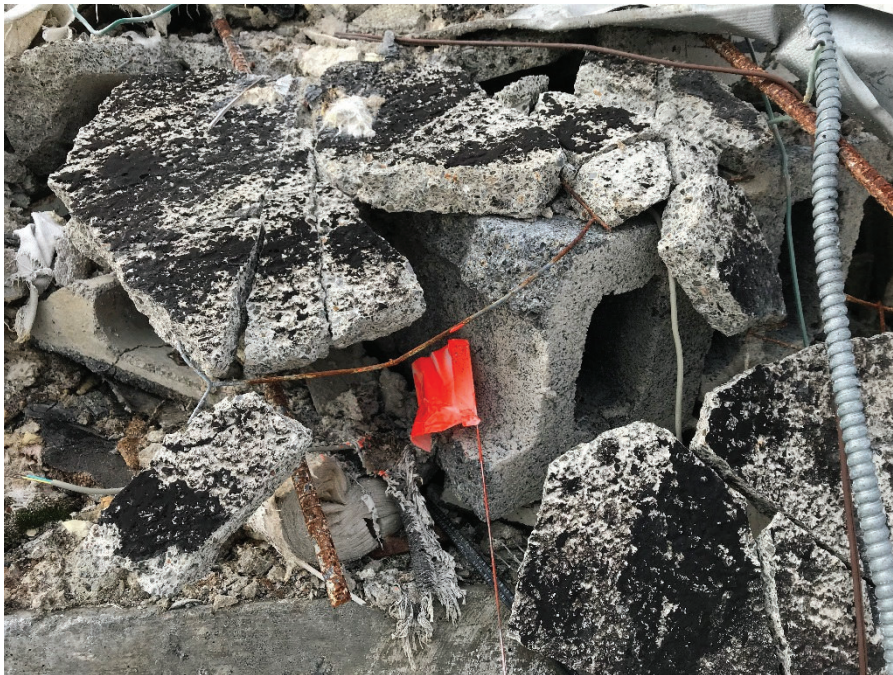
Photograph 14: View of sample location P001-BULK015 from which P001-BULK015-01 was collected.

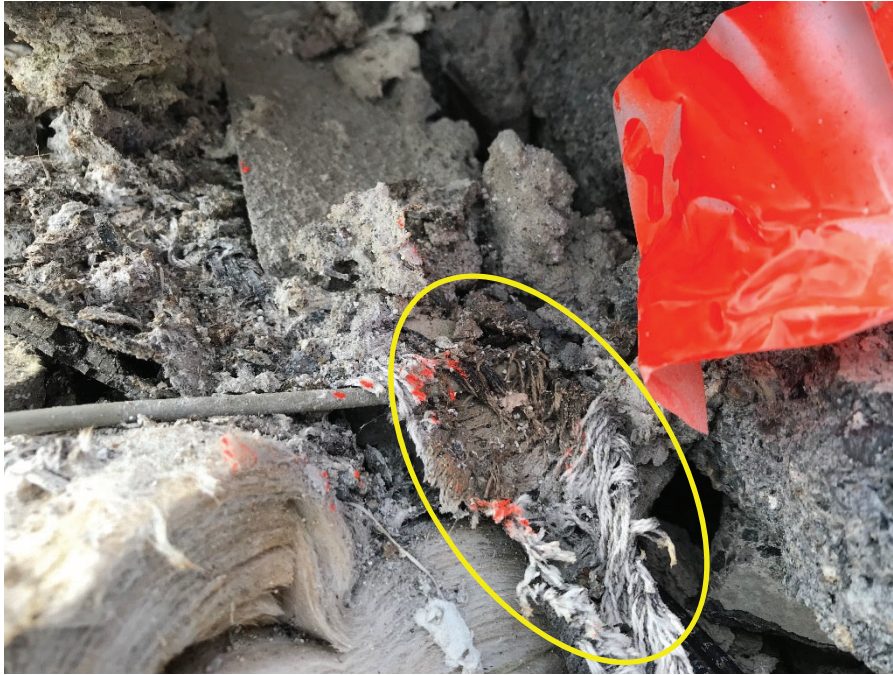
Photograph 15: Close up view of P001-BULK015-01. The bulk SACM sample is suspected to be degraded insulation.

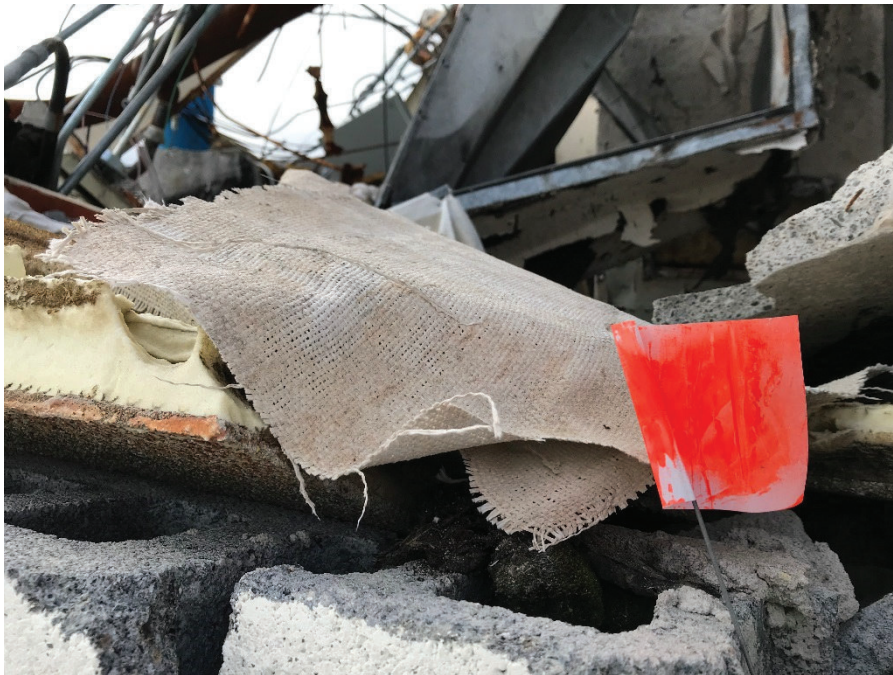
Photograph 16: View of sample location P001-BULK016 from which P001-BULK016-01 was collected. The bulk SACM sample is suspected to be furnace wrap.

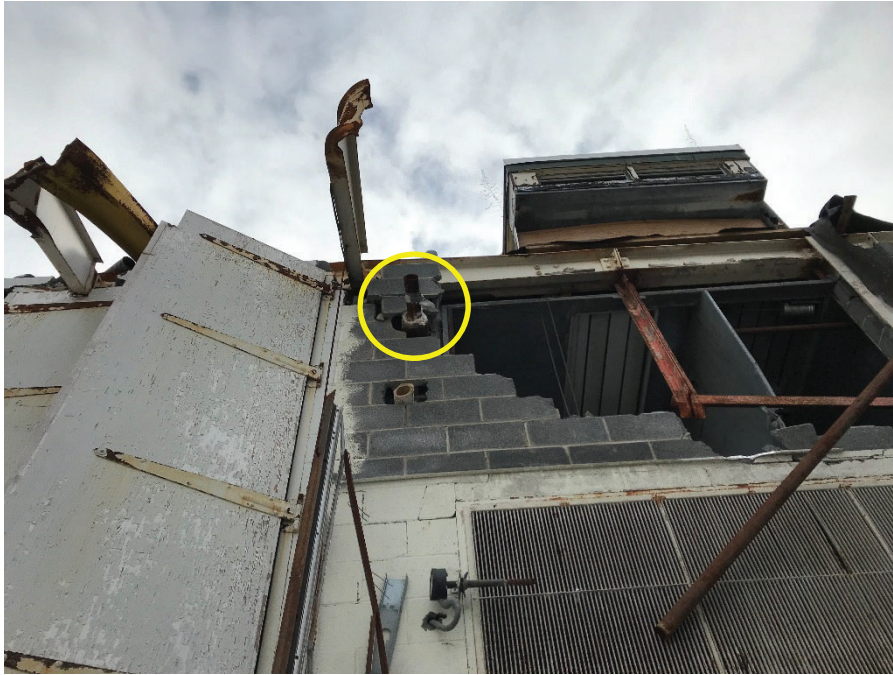
Photograph 17: View of sample location P001-BULK017 from which P001-BULK017-01 was collected. The bulk SACM sample is suspected to be pipe insulation.

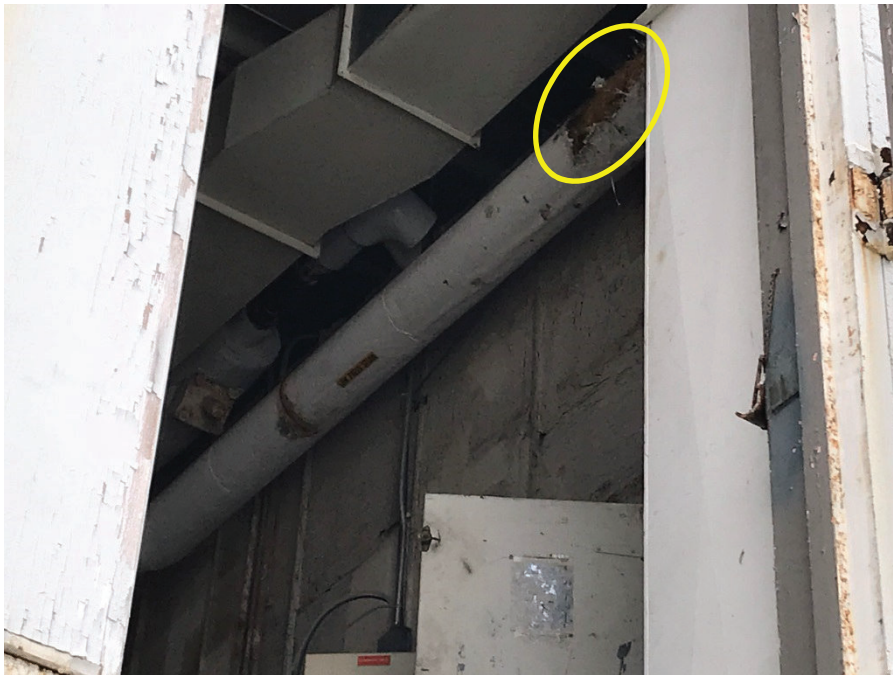
Photograph 18: View of sample location P001-BULK018 from which P001-BULK018-01 was collected. The bulk SACM sample is suspected to be interior pipe wrap.

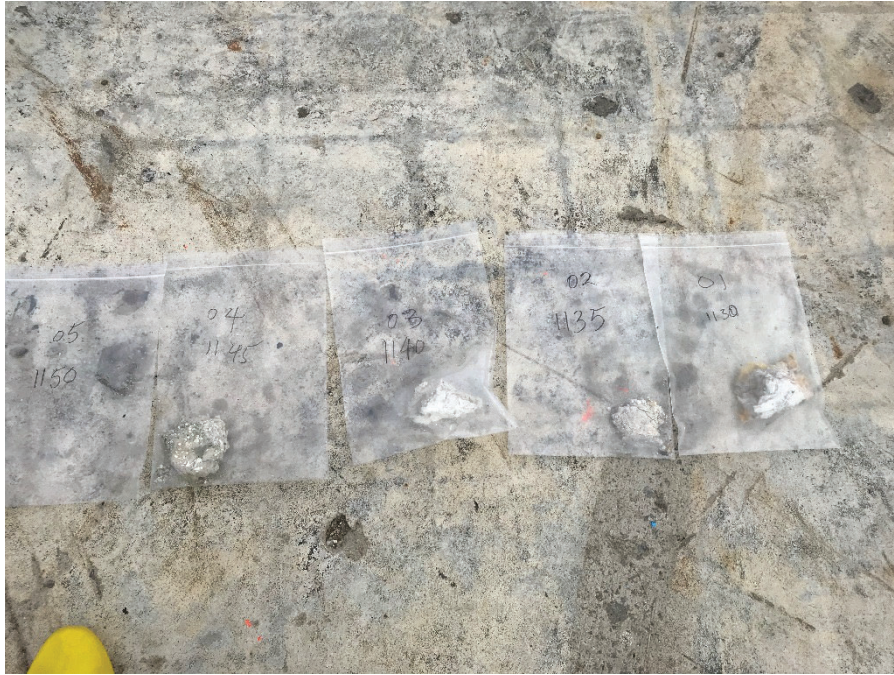
Photograph 19: View of some bulk SACM samples which were collected during the Removal Assessment sampling event and identified in the field as samples 01 through 05, but later renamed to correspond with P001-BULK009-01 through P001-BULK013-01, respectively.

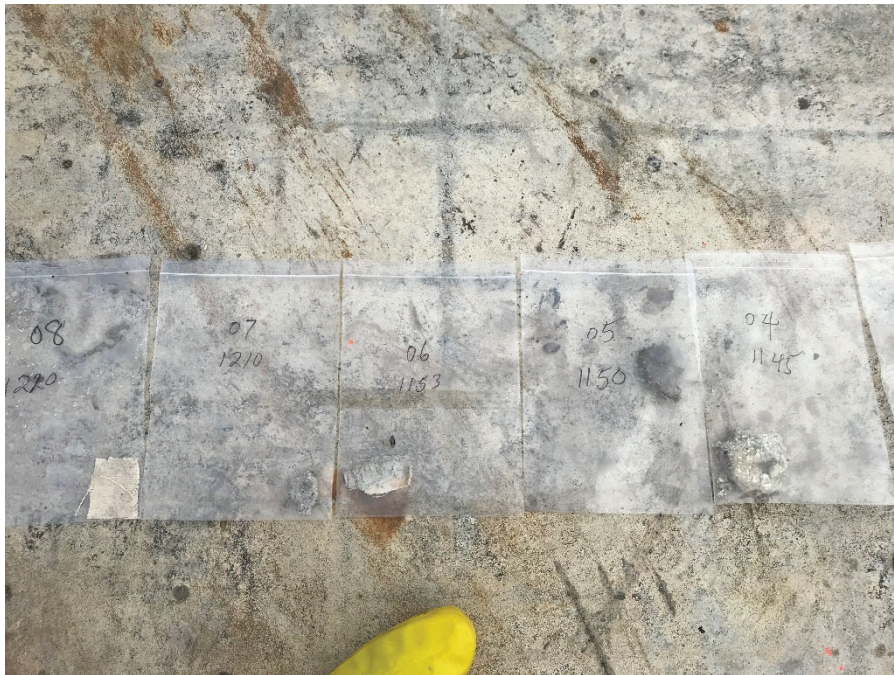
Photograph 20: View of some bulk SACM samples which were collected during the Removal Assessment sampling event and identified in the field as samples 04 through 08, but later renamed to correspond with P001-BULK012-01 through P001-BULK016-01, respectively.

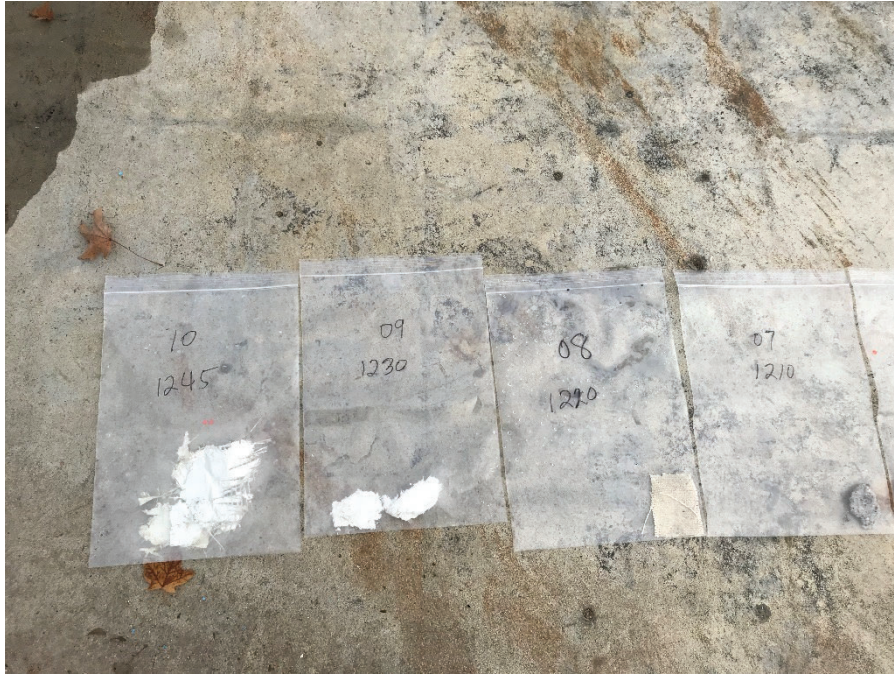
Photograph 21: View of some bulk SACM samples which were collected during the Removal Assessment sampling event and identified in the field as samples 07 through 10, but later renamed to correspond with P001-BULK015-01 through P001-BULK018-01, respectively.

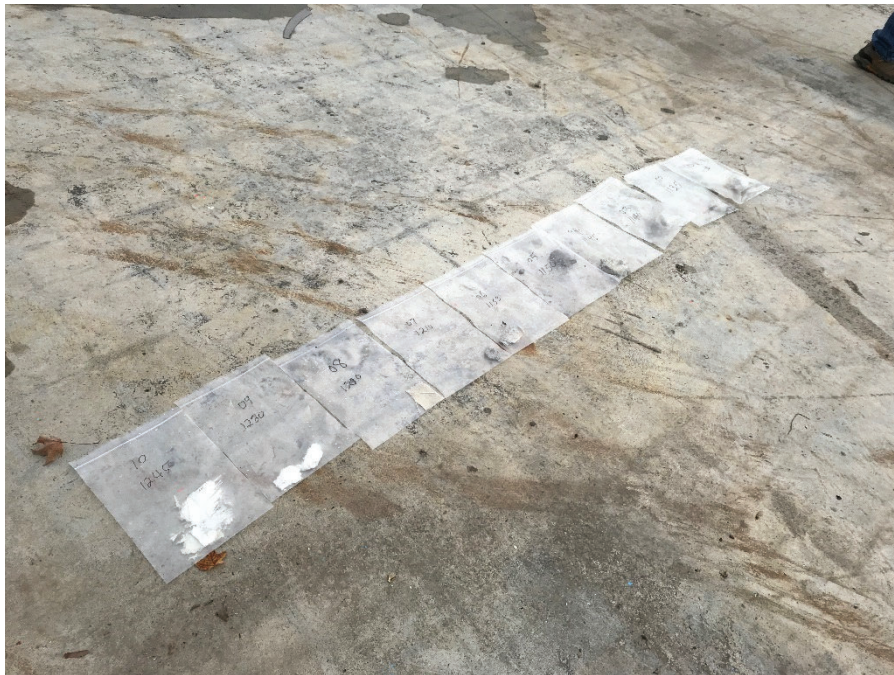
Photograph 22: View of all 10 bulk SACM samples collected during the Removal Assessment sampling event and identified in the field as samples 01 through 10, but later renamed to correspond with P001-BULK009-01 through P001-BULK018-01, respectively.
